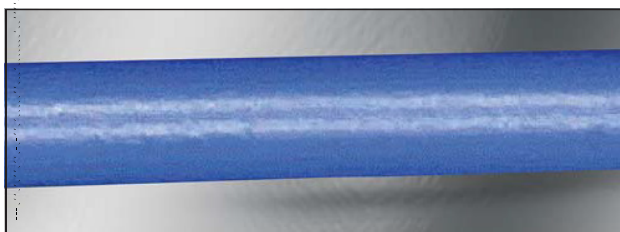
Figure 8-80 Example of Undamaged Insulation Jacket

No damage (burns, cuts, tears, etc.), contamination or any other anomaly.

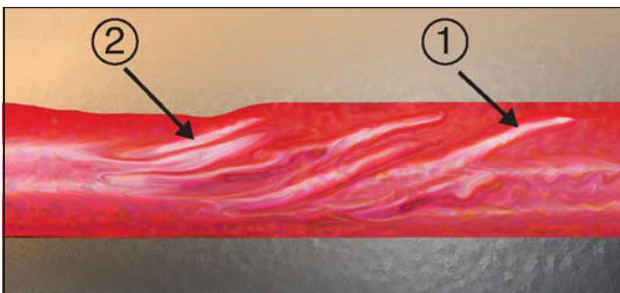
Figure 8-83 Creasing/Rippling of Outer Jacket
 1. A1A2A3: Crease/ripple does not exceed insulation jacket thickness.
 2. D1D2D3: Crease/ripple exceeds insulation jacket thickness.

- Crease/ripple does not exceed insulation jacket thickness.
- Test: Attenuation (loss) is within link loss budget limits.

- Crease/ripple exceeds insulation jacket thickness.
- Test: Attenuation (loss) exceeds link loss budget limit.
